**Flood Control Project Maintenance
Levee Inspections**

Maintenance Issue Types Only, Levee Inspection Report By Mile - Spring 2017

Sacramento River West Side Levee District

Waterway	Bank	Unit Miles	Inspection Start/End	Inspector
Unit No. 01 Sacramento River	Right	49.64	03/21/2017 03/22/2017	Zach Jojola

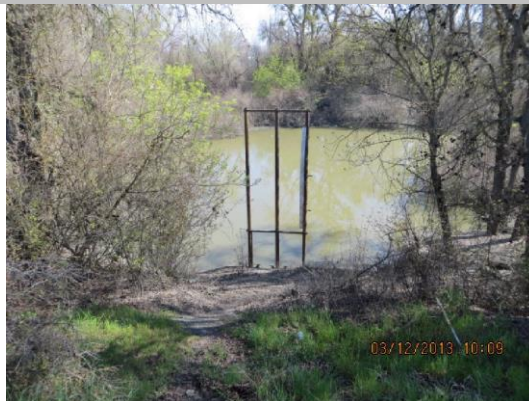
Photo 2 of 3 : UCIP_SP_2017_10085_17226.jpg

LM Start	0.14	Rating **	M	Issue No.	1552 (cont)
LM End	0.14	Issue Type +	Ma	Location *	WS
Category	Supplemental			GPS Latitude/Longitude	
				Start	End
Item	DWR UCIP LMA Responsibility			38.801479 °	38.801479 °
				-121.725176 °	-121.725176 °
DWR ID					
Comment Code					
Inspector Comment					
FS_ID:10085					
DS_ID:20356					
EP_NO: N/A					
Repair Type: Non-Urgent					
Crossing Status: Found					
UCIP Comments: Headwall undermined 3-4-feet on WS toe.					
FIELD_STRUCT_DESC: 2 of 3: 36-inch steel drainage pipe through					
levee 30.0 feet below crown. Flap gate on the waterward end. 24-inch					
pipe sleeved through the 36-inch pipe. Annular space between pipes					
grouted. Pumps in pumphouse with walkway on LS toe. Originally					
included in the 1960 O&M manual.					
FS Date: 3/12/2013

Air vents on pipes at WS toe.

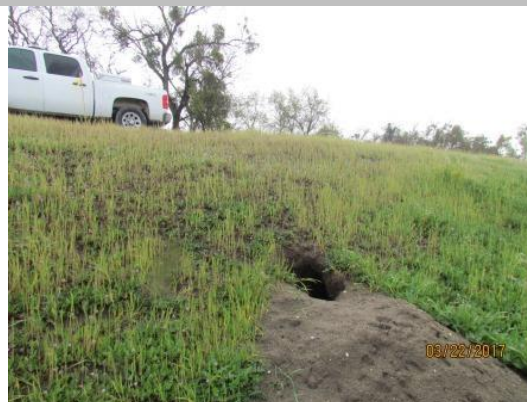
Photo 1 of 1 : SP_2017_NA0016_435_211_20170417_00333.jpg

LM Start	0.96	Rating **	U	Issue No.	211
LM End	0.96	Issue Type +	Ma	Location *	LS
Category	Earthen Levee		GPS Latitude/Longitude		
			Start	End	
Item	Animal Control		38.812460 °	38.812460 °	
			-121.724525 °	-121.724525 °	
DWR ID	DWR_NA0016_01_s _ 2017_211				
Comment Code					
A3 : No rodents visible, but rodent burrows visible; need to backfill and compact or grout burrows.					
Inspector Comment					
Large burrow hole on lanside levee slope.

Large burrow hole on lanside levee slope. Spring 2017.

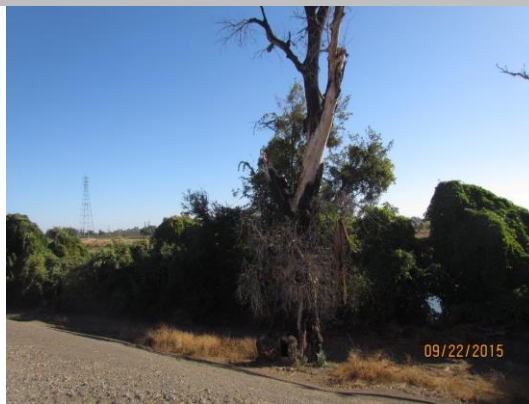
Photo 1 of 1 : SP_2017_NA0016_435_82_20170320_00037.jpg

LM Start	1.28	Rating **	A/W	Issue No.	82
LM End	1.28	Issue Type +	Ma	Location *	WS
Category	Earthen Levee			GPS Latitude/Longitude	
				Start	End
Item	Vegetation			38.817036 °	38.817036 °
				-121.725410 °	-121.725410 °
DWR ID	DWR_NA0016_01_s_2014_82				
Comment Code					
V7 : Trees / Woody Vegetation					
Inspector Comment

View of the dying tree on the waterward side of the levee. Monitor trees that could pose a threat to the integrity of the levee. Fall 2015.

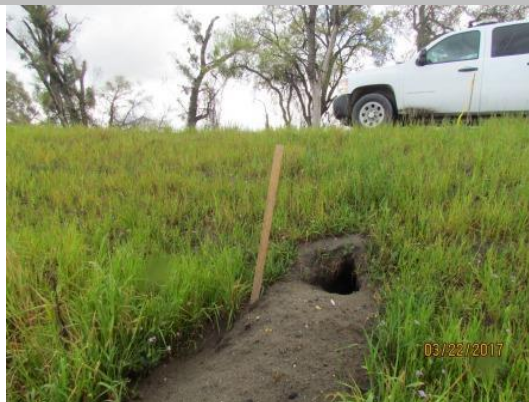
Photo 1 of 1 : SP_2017_NA0016_435_212_20170417_00334.jpg

LM Start	1.54	Rating **	M	Issue No.	212
LM End	1.54	Issue Type +	Ma	Location *	LS
Category	Earthen Levee			GPS Latitude/Longitude	
				Start	End
Item	Animal Control			38.820885 °	38.820885 °
				-121.724939 °	-121.724939 °
DWR ID	DWR_NA0016_01_s_2017_212				
Comment Code					
A3 : No rodents visible, but rodent burrows visible; need to backfill and compact or grout burrows.					
Inspector Comment					
Large burrow hole on lanside levee slope.

Large burrow hole on landside levee slope. Spring 2017.

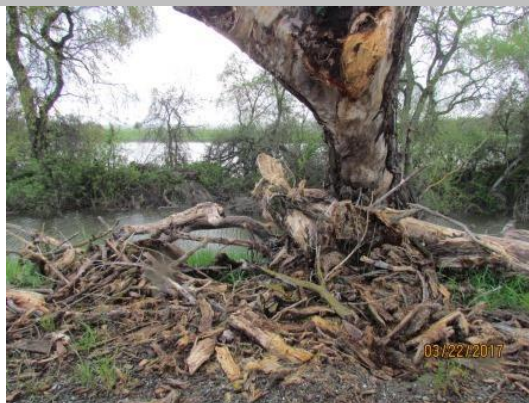
Photo 1 of 2 : SP_2017_NA0016_435_84_20170417_00335.jpg

LM Start	1.87	Rating **	M	Issue No.	84
LM End	1.87	Issue Type +	Ma	Location *	WS
Category	Earthen Levee			GPS Latitude/Longitude	
				Start	End
Item	Encroachments			38.825534 °	38.825534 °
				-121.724749 °	-121.724749 °
DWR ID	DWR_NA0016_01_s_2014_84				
Comment Code					
TR : Tree or limb					
Inspector Comment					
Fallen tree on waterside levee slope.

View of fallen tree on waterside slope, looking towards river. Spring 2017.

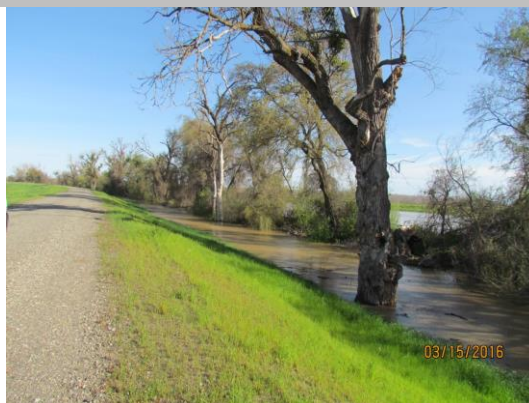
Photo 2 of 2 : SP_2017_NA0016_435_84_20170320_00039.jpg

LM Start	1.87	Rating **	M	Issue No.	84 (cont)
LM End	1.87	Issue Type +	Ma	Location *	WS

View of the tree on the waterward side of the levee looking upstream. Spring 2016.

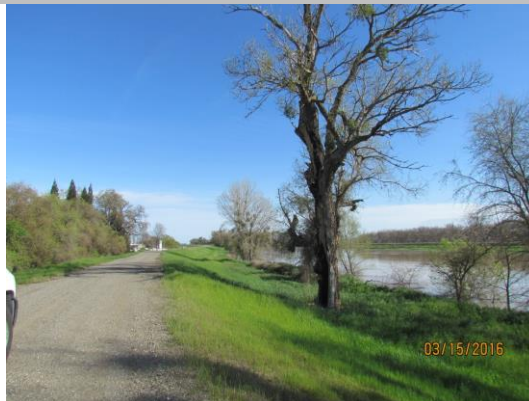
Photo 1 of 1 : SP_2017_NA0016_435_150_20170320_00075.jpg

LM Start	2.70	Rating **	A/W	Issue No.	150
LM End	2.70	Issue Type +	Ma	Location *	WS
Category	Earthen Levee			GPS Latitude/Longitude	
				Start	End
Item	Vegetation			38.835831 °	38.835831 °
				-121.732077 °	-121.732077 °
DWR ID	DWR_NA0016_01_s_2016_150				
Comment Code					
V7 : Trees / Woody Vegetation					
Inspector Comment					
Monitor trees that pose a future threat to the integrity of the levee.

View of the tree on the waterward side of the levee looking upstream.
Spring 2016.

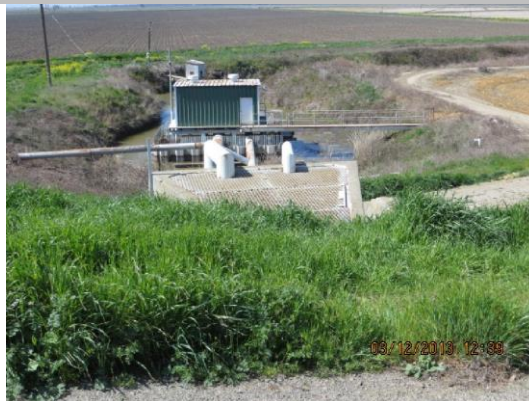
Photo 2 of 3 : UCIP_SP_2017_10125_17282.jpg

LM Start	3.54	Rating **	A/W	Issue No.	1556 (cont)	
LM End	3.54	Issue Type +	Ma	Location *	LS	
Category	Supplemental			GPS Latitude/Longitude		
				Start	End	
Item	DWR UCIP LMA Responsibility			38.846492 °	38.846492 °	
				-121.730066 °	-121.730066 °	
DWR ID						
Comment Code						
Inspector Comment						
FS_ID:10125						
DS_ID:20331						
EP_NO: N/A						
Repair Type: No Action Needed						
Crossing Status: Found						
UCIP Comments:						
FIELD_STRUCT_DESC: 5'x 5' concrete tunnel through levee 33.0 feet below crown. Slide gate at outlet on WS toe. Tunnel runs from Concrete V-shaped riser on LS shoulder to WS toe. Steel walkway to slide gate acuator on WS berm. Originally included in the 1960 O&M manual.						
FS Date: 3/12/2013

Pumphouse at LS toe and concrete riser on LS shoulder.

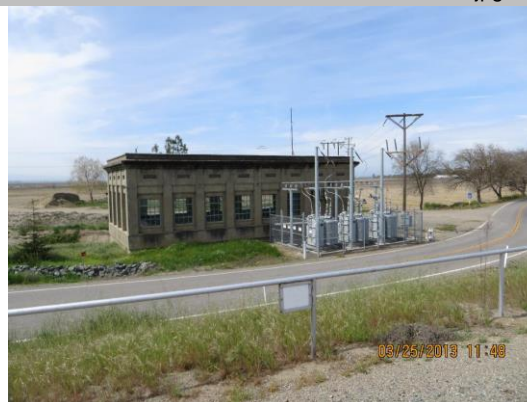
Photo 1 of 3 : UCIP_SP_2017_10146_17312.jpg

LM Start	8.89	Rating **	A/W	Issue No.	1562
LM End	8.89	Issue Type +	Ma	Location *	WS
Category	Supplemental			GPS Latitude/Longitude	
				Start	End
Item	DWR UCIP LMA Responsibility			38.856531 °	38.856531 °
				-121.785605 °	-121.785605 °
DWR ID					
Comment Code					
Inspector Comment					
FS_ID:10146 DS_ID:20230 EP_NO: 9376 Repair Type: No Action Needed Crossing Status: Found UCIP Comments: FIELD_STRUCT_DESC: 1 of 4: 54-inch steel pipe encased in concrete through levee 26.5 feet below crown. (Permit No. 9376, 1960). Gate valves on waterward ends of the pipes. Walkway provided to the control valves and around pumphouse on LS. Pipes originate in a large concrete pool at pumphouse on LS. Originally included in the 1960 O&M manual. FS Date: 3/13/2013

Pumphouse on LS toe.

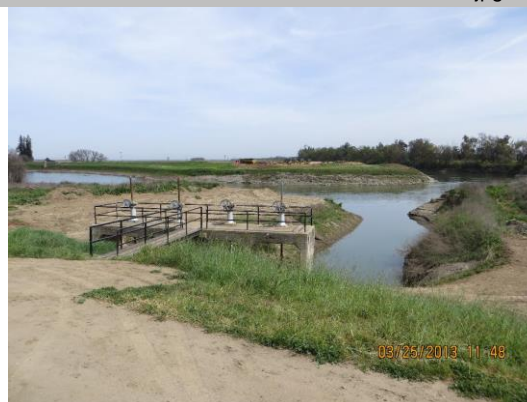
Photo 2 of 3 : UCIP_SP_2017_10146_17311.jpg

LM Start	8.89	Rating **	A/W	Issue No.	1562 (cont)
LM End	8.89	Issue Type +	Ma	Location *	WS

Walkway to slide gate actuators on WS shoulder.

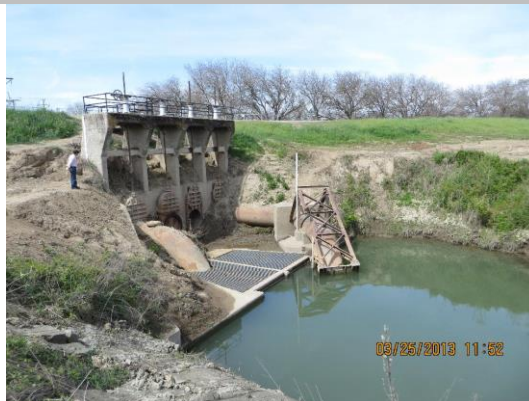
Photo 3 of 3 : UCIP_SP_2017_10146_17310.jpg

LM Start	8.89	Rating **	A/W	Issue No.	1562 (cont)
LM End	8.89	Issue Type +	Ma	Location *	WS
Category	Supplemental			GPS Latitude/Longitude	
				Start	End
Item	DWR UCIP LMA Responsibility			38.856531 °	38.856531 °
				-121.785605 °	-121.785605 °
DWR ID					
Comment Code					
Inspector Comment					
FS_ID:10146 DS_ID:20230 EP_NO: 9376 Repair Type: No Action Needed Crossing Status: Found UCIP Comments: FIELD_STRUCT_DESC: 1 of 4: 54-inch steel pipe encased in concrete through levee 26.5 feet below crown. (Permit No. 9376, 1960). Gate valves on waterward ends of the pipes. Walkway provided to the control valves and around pumphouse on LS. Pipes originate in a large concrete pool at pumphouse on LS. Originally included in the 1960 O&M manual. FS Date: 3/13/2013

Pipes at outlet on WS toe.

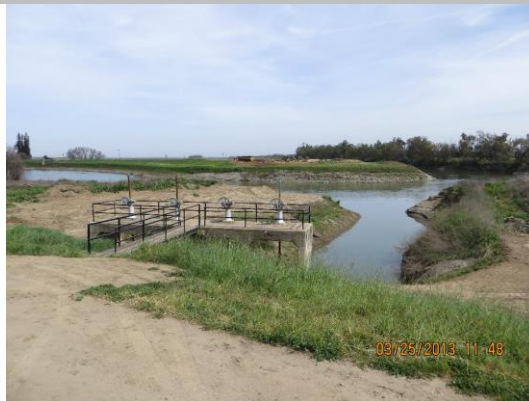
Photo 2 of 3 : UCIP_SP_2017_10147_17315.jpg

LM Start	8.90	Rating **	A/W	Issue No.	1563 (cont)	
LM End	8.90	Issue Type +	Ma	Location *	WS	
Category	Supplemental			GPS Latitude/Longitude		
				Start	End	
Item	DWR UCIP LMA Responsibility			38.856554 °	38.856554 °	
				-121.785613 °	-121.785613 °	
DWR ID						
Comment Code						
Inspector Comment						
FS_ID:10147						
DS_ID:20361						
EP_NO: 9376						
Repair Type: No Action Needed						
Crossing Status: Found						
UCIP Comments:						
FIELD_STRUCT_DESC: 2 of 4: 54-inch steel discharge pipe encased in concrete through levee 26.5 feet below crown. (Permit No. 9376, 1960) Gate valves on both ends of the pipes. Walkway provided to the gate valves on WS shoulder. Originally included in the 1960 O&M manual. Pipe not visible on LS toe.						
FS Date: 3/13/2013

Walkway to slide gate actuators on WS shoulder.

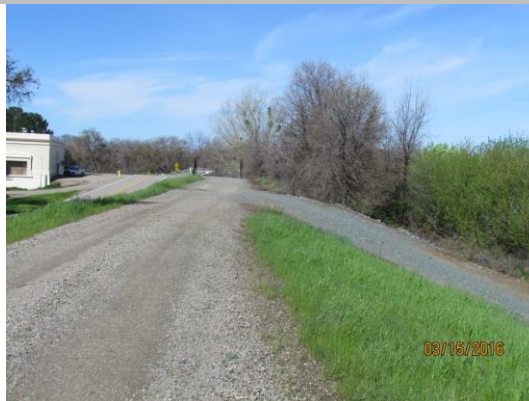
Photo 1 of 2 : SP_2017_NA0016_435_29_20170320_00021.jpg

LM Start	9.68	Rating **	A/W	Issue No.	29
LM End	9.79	Issue Type +	Ma	Location *	WS
Category	Earthen Levee			GPS Latitude/Longitude	
				Start	End
Item	Vegetation			38.862345 °	38.862848 °
				-121.791337 °	-121.793267 °
DWR ID	DWR_NA0016_01_s_2012_29				
Comment Code					
V8 : Environmental Requirements.					
Inspector Comment

View of the revegetation site on the waterward side of the levee looking upstream. Spring 2016.

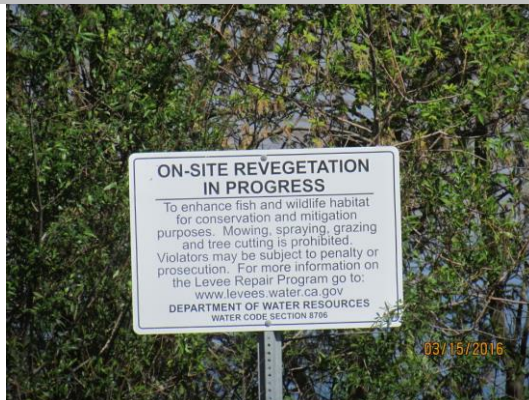
Photo 2 of 2 : SP_2017_NA0016_435_29_20170320_00022.jpg

LM Start	9.68	Rating **	A/W	Issue No.	29 (cont)
LM End	9.79	Issue Type +	Ma	Location *	WS

Revegetation site sign. Spring 2016.

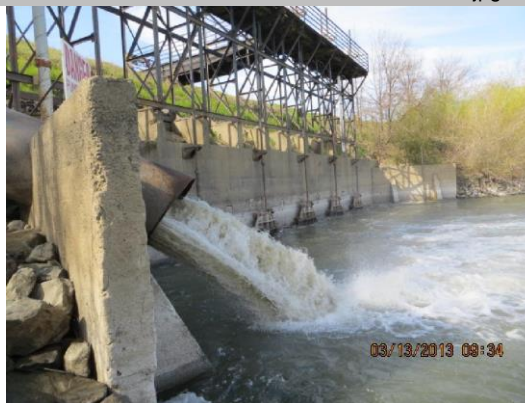
Photo 1 of 3 : UCIP_SP_2017_10163_17342.jpg

LM Start	9.75	Rating **	A/W	Issue No.	1567
LM End	9.75	Issue Type +	Ma	Location *	WS
Category	Supplemental			GPS Latitude/Longitude	
				Start	End
Item	DWR UCIP LMA Responsibility			38.862619 °	38.862619 °
				-121.792510 °	-121.792510 °
DWR ID					
Comment Code					
Inspector Comment					
FS_ID:10163 DS_ID:20415 EP_NO: 680 Repair Type: No Action Needed Crossing Status: Found UCIP Comments: FIELD_STRUCT_DESC: 42-inch steel pipe through levee 17.5 feet below crown. Screw gate on the waterward end. Pump on platform in canal on LS toe. 12-inch standpipe along alignment on LS toe. (Permit No. 680, 1936). Staff gauge to 47.0 feet on structure. Included in the 1960 O&M manual. FS Date: 3/13/2013

Pipe at outlet on WS toe.

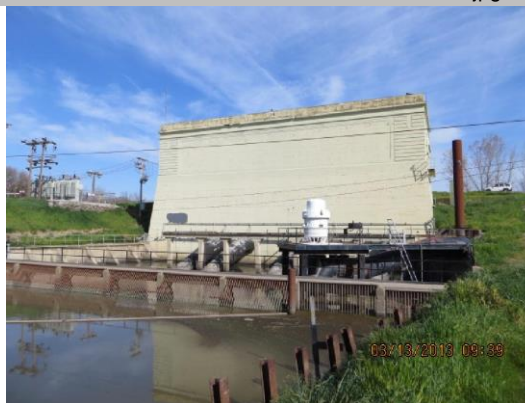
Photo 3 of 3 : UCIP_SP_2017_10165_17346.jpg

LM Start	9.76	Rating **	A/W	Issue No.	1569 (cont)
LM End	9.76	Issue Type +	Ma	Location *	WS
Category	Supplemental			GPS Latitude/Longitude	
				Start	End
Item	DWR UCIP LMA Responsibility			38.862624 °	38.862624 °
				-121.792626 °	-121.792626 °
DWR ID					
Comment Code					
Inspector Comment					
FS_ID:10165					
DS_ID:20364					
EP_NO: N/A					
Repair Type: No Action Needed					
Crossing Status: Found					
UCIP Comments:					
FIELD_STRUCT_DESC: 2 of 5: 60-inch concrete culverts through levee					
35.0 feet below crown. Screw gate actuators on metal platform at					
waterward shoulder. Large pumping plant building on LS shoulder.					
Originally included in the 1960 O&M manual. Staff gauge to 47.0 feet					
on structure.					
FS Date: 3/13/2013

Pumphouse on LS.

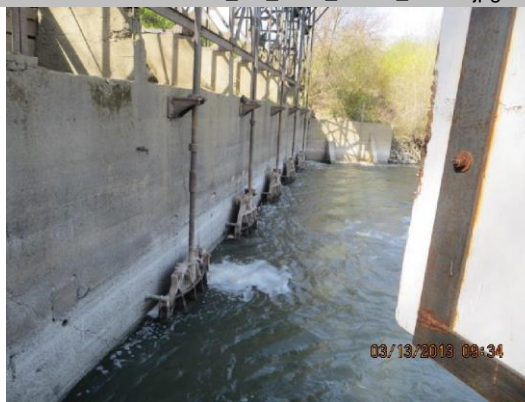
Photo 1 of 3 : UCIP_SP_2017_10168_17360.jpg

LM Start	9.76	Rating **	A/W	Issue No.	1570
LM End	9.76	Issue Type +	Ma	Location *	WS
Category	Supplemental			GPS Latitude/Longitude	
				Start	End
Item	DWR UCIP LMA Responsibility			38.862633 °	38.862633 °
				-121.792669 °	-121.792669 °
DWR ID					
Comment Code					
Inspector Comment					
FS_ID:10168 DS_ID:20365 EP_NO: N/A Repair Type: No Action Needed Crossing Status: Found UCIP Comments: FIELD_STRUCT_DESC: 3 of 5: 60-inch concrete culverts through levee 35.0 feet below crown. Screw gate actuators on metal platform at waterward shoulder. Large pumping plant building on LS shoulder. Originally included in the 1960 O&M manual. Staff gauge to 47.0 feet on structure. FS Date: 3/13/2013

Slide gate and concrete headwall on WS toe.

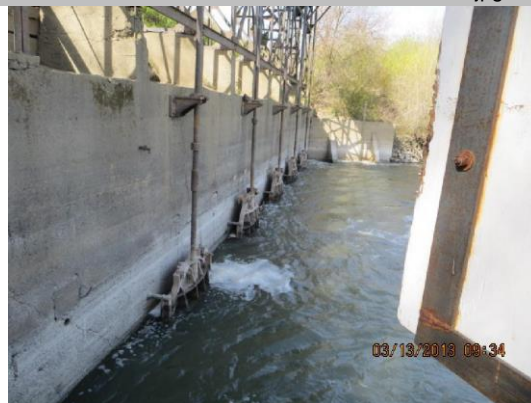
Photo 1 of 3 : UCIP_SP_2017_10167_17352.jpg

LM Start	9.76	Rating **	A/W	Issue No.	1571
LM End	9.76	Issue Type +	Ma	Location *	WS
Category	Supplemental			GPS Latitude/Longitude	
				Start	End
Item	DWR UCIP LMA Responsibility			38.862642 °	38.862642 °
				-121.792713 °	-121.792713 °
DWR ID					
Comment Code					
Inspector Comment					
FS_ID:10167					
DS_ID:20366					
EP_NO: N/A					
Repair Type: No Action Needed					
Crossing Status: Found					
UCIP Comments:					
FIELD_STRUCT_DESC: 4 of 5: 60-inch concrete culverts through levee					
35.0 feet below crown. Screw gate actuators on metal platform at					
waterward shoulder. Large pumping plant building on LS shoulder.					
Originally included in the 1960 O&M manual. Staff gauge to 47.0 feet					
on structure.					
FS Date: 3/13/2013

Slide gates and headwall at WS toe.

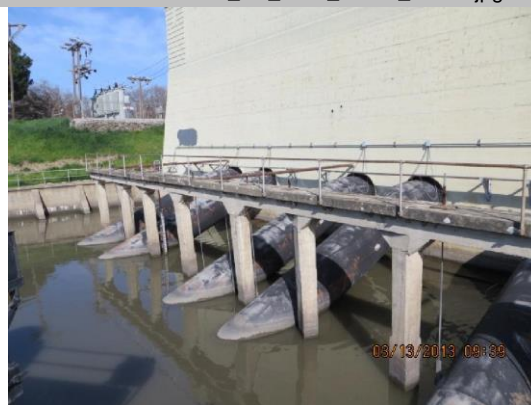
Photo 2 of 3 : UCIP_SP_2017_10167_17351.jpg

LM Start	9.76	Rating **	A/W	Issue No.	1571 (cont)
LM End	9.76	Issue Type +	Ma	Location *	WS

Pipes at inlet to pumping plant on LS toe.

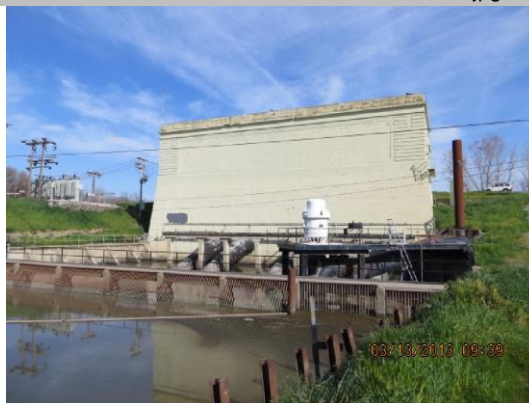
Photo 3 of 3 : UCIP_SP_2017_10167_17350.jpg

LM Start	9.76	Rating **	A/W	Issue No.	1571 (cont)	
LM End	9.76	Issue Type +	Ma	Location *	WS	
Category	Supplemental			GPS Latitude/Longitude		
				Start	End	
Item	DWR UCIP LMA Responsibility			38.862642 °	38.862642 °	
				-121.792713 °	-121.792713 °	
DWR ID						
Comment Code						
Inspector Comment						
FS_ID:10167						
DS_ID:20366						
EP_NO: N/A						
Repair Type: No Action Needed						
Crossing Status: Found						
UCIP Comments:						
FIELD_STRUCT_DESC: 4 of 5: 60-inch concrete culverts through levee						
35.0 feet below crown. Screw gate actuators on metal platform at						
waterward shoulder. Large pumping plant building on LS shoulder.						
Originally included in the 1960 O&M manual. Staff gauge to 47.0 feet						
on structure.						
FS Date: 3/13/2013

Pumping plant on LS.

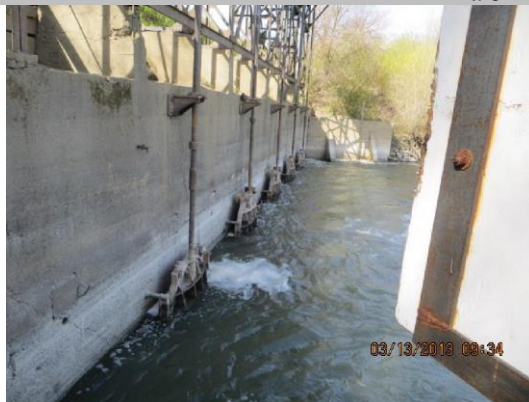
Photo 1 of 3 : UCIP_SP_2017_10169_17364.jpg

LM Start	9.76	Rating **	A/W	Issue No.	1572
LM End	9.76	Issue Type +	Ma	Location *	WS
Category	Supplemental			GPS Latitude/Longitude	
				Start	End
Item	DWR UCIP LMA Responsibility			38.862650 °	38.862650 °
				-121.792754 °	-121.792754 °
DWR ID					
Comment Code					
Inspector Comment					
FS_ID:10169 DS_ID:20367 EP_NO: N/A Repair Type: No Action Needed Crossing Status: Found UCIP Comments: FIELD_STRUCT_DESC: 5 of 5: 60-inch concrete culverts through levee 35.0 feet below crown. Screw gate actuators on metal platform at waterward shoulder. Large pumping plant building on LS shoulder. Originally included in the 1960 O&M manual. Staff gauge to 47.0 feet on structure. FS Date: 3/13/2013

Slide gates and concrete headwall on WS toe.

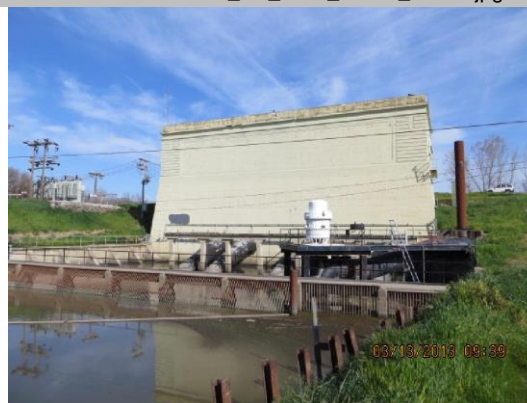
Photo 3 of 3 : UCIP_SP_2017_10169_17362.jpg

LM Start	9.76	Rating **	A/W	Issue No.	1572 (cont)
LM End	9.76	Issue Type +	Ma	Location *	WS

Pumphouse on LS.

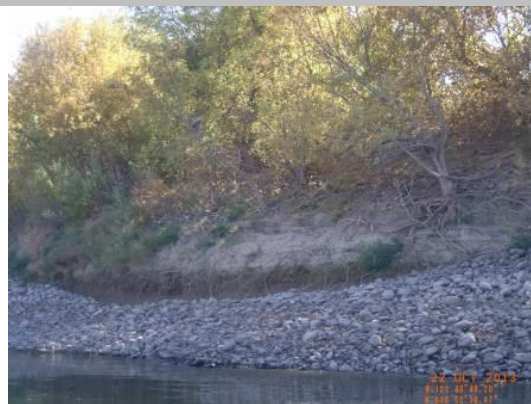
Photo 1 of 1 : SP_2017_NA0016_435_7_20170320_00007.jpg

LM Start	11.50	Rating **	M	Issue No.	7
LM End	11.53	Issue Type +	Ma	Location *	WS
Category	Supplemental		GPS Latitude/Longitude		
			Start	End	
Item	2015 USACE Erosion Survey, DRAFT		38.874854 °	38.875109 °	
			-121.813018 °	-121.813592 °	
DWR ID	DWR_NA0016_01_s _ 2016_7				
Comment Code					
Inspector Comment					
1997 - Toe damage and loss of cobble revetment and small patch of local damage to the cobble revetment. 2000 - Cohesive vertical toe; revegetation site. 2015: No observed changes. [2015 Site ID: SAC_101-3_R]

USACE 2013 Photo #1

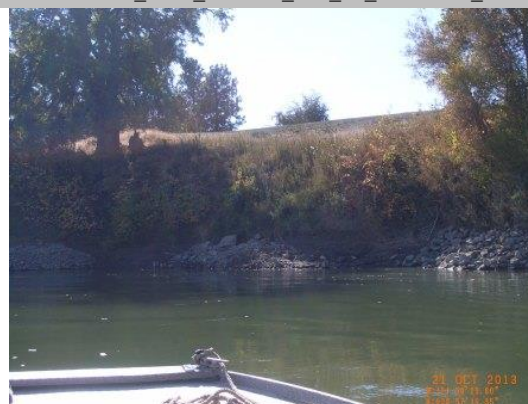
Photo 1 of 1 : SP_2017_NA0016_435_10_20170320_00010.jpg

LM Start	18.76	Rating **	M	Issue No.	10
LM End	18.78	Issue Type +	Ma	Location *	WS
Category	Supplemental			GPS Latitude/Longitude	
				Start	End
Item	2015 USACE Erosion Survey, DRAFT			38.954060 °	38.954312 °
				-121.840560 °	-121.840774 °
DWR ID	DWR_NA0016_01_s_2016_10				
Comment Code					
Inspector Comment					
2009 - Minor erosion, should be repaired under maintenance. 2011 - Some new minor erosion at the toe. 2015: No observed changes. [2015 Site ID: SAC_111-0_R]

USACE 2013 Photo #1

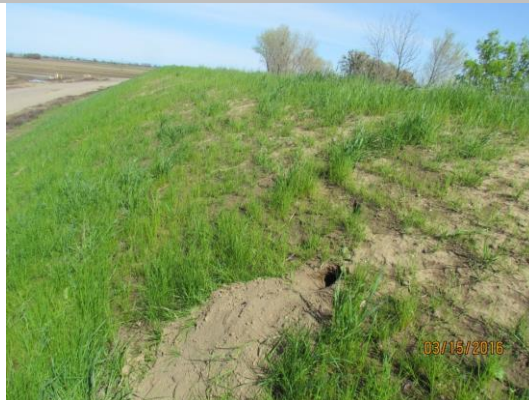
Photo 1 of 1 : SP_2017_NA0016_435_179_20170320_00095.jpg

LM Start	21.89	Rating **	M	Issue No.	179
LM End	21.89	Issue Type +	Ma	Location *	LS
Category	Earthen Levee			GPS Latitude/Longitude	
				Start	End
Item	Animal Control			38.988449 °	38.988449 °
				-121.820009 °	-121.820009 °
DWR ID	DWR_NA0016_01_s _ 2016_179				
Comment Code					
A3 : No rodents visible, but rodent burrows visible; need to backfill and compact or grout burrows.					
Inspector Comment

View of the rodent hole on the landward side of the levee looking upstream. Spring 2016.

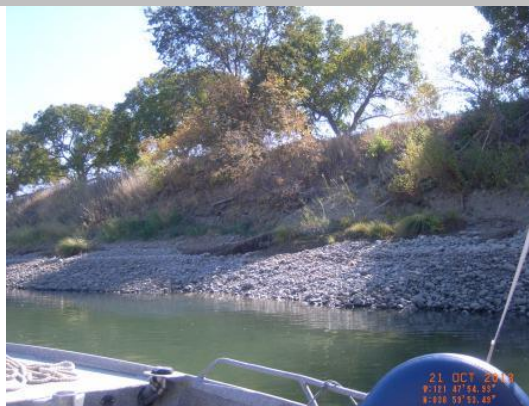
Photo 1 of 1 : SP_2017_NA0016_435_11_20170320_00011.jpg

LM Start	23.55	Rating **	M	Issue No.	11
LM End	23.65	Issue Type +	Ma	Location *	WS
Category	Supplemental			GPS Latitude/Longitude	
				Start	End
Item	2015 USACE Erosion Survey, DRAFT			38.997696 °	38.998336 °
				-121.797584 °	-121.799298 °
DWR ID	DWR_NA0016_01_s_2016_11				
Comment Code					
Inspector Comment					
2008 - Slippage of cobbles off hard underlying toe material. 2011 - Minor slumping site. 2012 - Failing cobble site, site extended upstream. 2015: No observed changes. [2015 Site ID: SAC_115-9_R]

USACE 2013 Photo #1

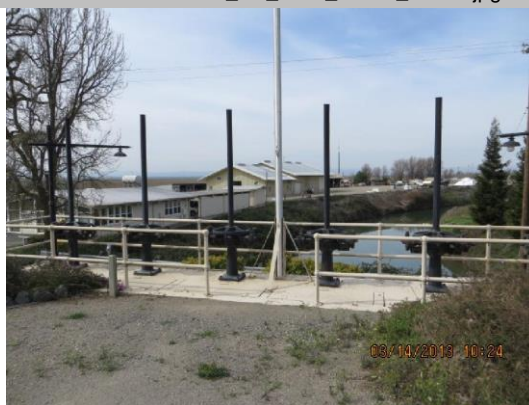
Photo 2 of 3 : UCIP_SP_2017_10271_17500.jpg

Slide gates on LS shoulder.

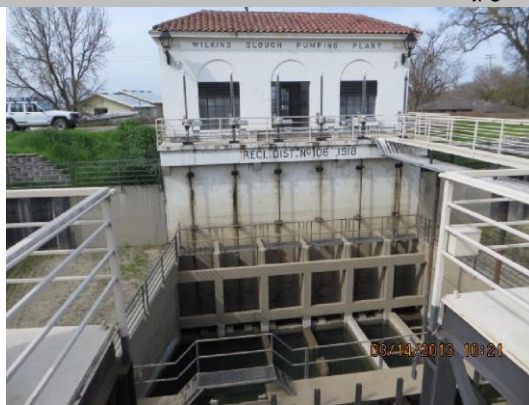
Photo 1 of 3 : UCIP_SP_2017_10284_17530.jpg

LM Start	25.57	Rating **	A/W	Issue No.	1580
LM End	25.57	Issue Type +	Ma	Location *	WS
Category	Supplemental			GPS Latitude/Longitude	
				Start	End
Item	DWR UCIP LMA Responsibility			39.012336 °	39.012336 °
				-121.827902 °	-121.827902 °
DWR ID					
Comment Code					
Inspector Comment					
FS_ID:10284 DS_ID:20370 EP_NO: 9354 Repair Type: No Action Needed Crossing Status: Found UCIP Comments: FIELD_STRUCT_DESC: 2 of 6: 5'x5' reinforced concrete culverts through levee 40.0 feet below crown (Permit No. 9354, 1960). Control gates on the landward and waterward shoulder. Pumps on the waterward berm. FS Date: 3/14/2013

Pumphouse on WS shoulder

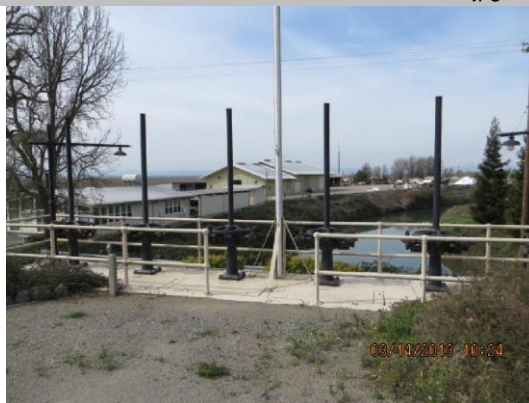
Photo 2 of 3 : UCIP_SP_2017_10284_17529.jpg

LM Start	25.57	Rating **	A/W	Issue No.	1580 (cont)	
LM End	25.57	Issue Type +	Ma	Location *	WS	
Category	Supplemental			GPS Latitude/Longitude		
				Start	End	
Item	DWR UCIP LMA Responsibility			39.012336 °	39.012336 °	
				-121.827902 °	-121.827902 °	
DWR ID						
Comment Code						
Inspector Comment						
FS_ID:10284 DS_ID:20370 EP_NO: 9354 Repair Type: No Action Needed Crossing Status: Found UCIP Comments: FIELD_STRUCT_DESC: 2 of 6: 5'x5' reinforced concrete culverts through levee 40.0 feet below crown (Permit No. 9354, 1960). Control gates on the landward and waterward shoulder. Pumps on the waterward berm. FS Date: 3/14/2013

Slide gates on LS shoulder.

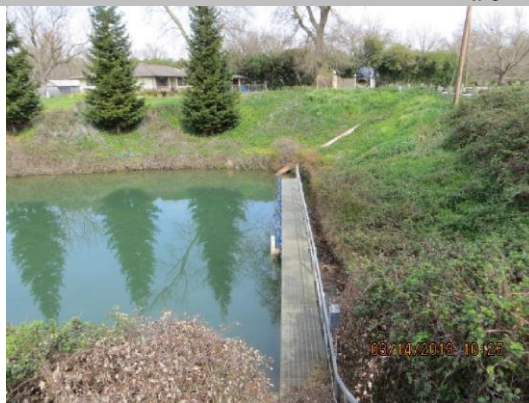
Photo 3 of 3 : UCIP_SP_2017_10284_17528.jpg

Walkway and gates in canal at LS toe.

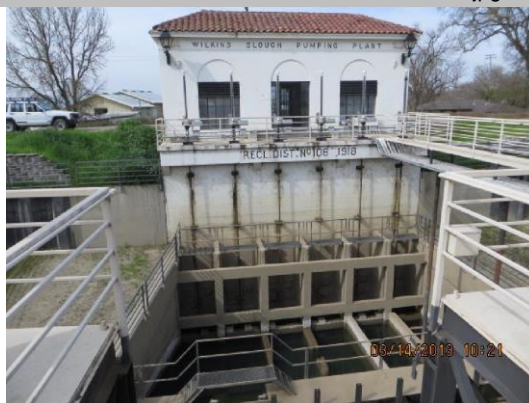
Photo 1 of 3 : UCIP_SP_2017_10277_17516.jpg

LM Start	25.57	Rating **	A/W	Issue No.	1582
LM End	25.57	Issue Type +	Ma	Location *	WS
Category	Supplemental			GPS Latitude/Longitude	
				Start	End
Item	DWR UCIP LMA Responsibility			39.012365 °	39.012365 °
				-121.827921 °	-121.827921 °
DWR ID					
Comment Code					
Inspector Comment					
FS_ID:10277 DS_ID:20372 EP_NO: 9354 Repair Type: No Action Needed Crossing Status: Found UCIP Comments: FIELD_STRUCT_DESC: 4 of 6: 5'x5' reinforced concrete culverts through levee 40.0 feet below crown (Permit No. 9354, 1960). Control gates on the landward and waterward shoulder. Pumps on the waterward berm. FS Date: 3/14/2013

Pumphouse on WS shoulder.

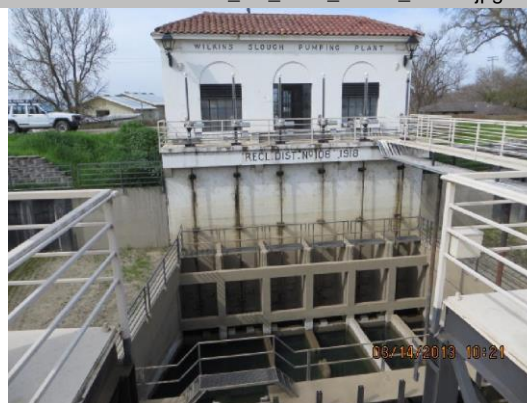
Photo 1 of 3 : UCIP_SP_2017_10278_17519.jpg

LM Start	25.57	Rating **	A/W	Issue No.	1583
LM End	25.57	Issue Type +	Ma	Location *	WS
Category	Supplemental			GPS Latitude/Longitude	
				Start	End
Item	DWR UCIP LMA Responsibility			39.012383 °	39.012383 °
				-121.827921 °	-121.827921 °
DWR ID					
Comment Code					
Inspector Comment					
FS_ID:10278					
DS_ID:20373					
EP_NO: 9354					
Repair Type: No Action Needed					
Crossing Status: Found					
UCIP Comments:					
FIELD_STRUCT_DESC: 5 of 6: 5'x5' reinforced concrete culverts					
through levee 40.0 feet below crown (Permit No. 9354, 1960). Control					
gates on the landward and waterward shoulder. Pumps on the					
waterward berm.					
FS Date: 3/14/2013

Pumphouse on WS shoulder.

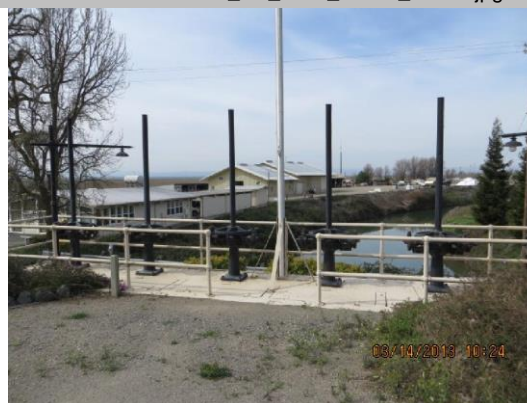
Photo 2 of 3 : UCIP_SP_2017_10278_17518.jpg

Slide gates on LS shoulder.

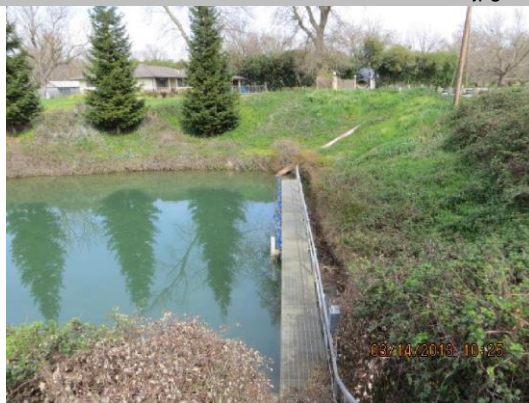
Photo 3 of 3 : UCIP_SP_2017_10278_17517.jpg

LM Start	25.57	Rating **	A/W	Issue No.	1583 (cont)	
LM End	25.57	Issue Type +	Ma	Location *	WS	
Category	Supplemental			GPS Latitude/Longitude		
				Start	End	
Item	DWR UCIP LMA Responsibility			39.012383 °	39.012383 °	
				-121.827921 °	-121.827921 °	
DWR ID						
Comment Code						
Inspector Comment						
FS_ID:10278						
DS_ID:20373						
EP_NO: 9354						
Repair Type: No Action Needed						
Crossing Status: Found						
UCIP Comments:						
FIELD_STRUCT_DESC: 5 of 6: 5'x5' reinforced concrete culverts						
through levee 40.0 feet below crown (Permit No. 9354, 1960). Control						
gates on the landward and waterward shoulder. Pumps on the						
waterward berm.						
FS Date: 3/14/2013

Walkway and gates on LS toe at canal.

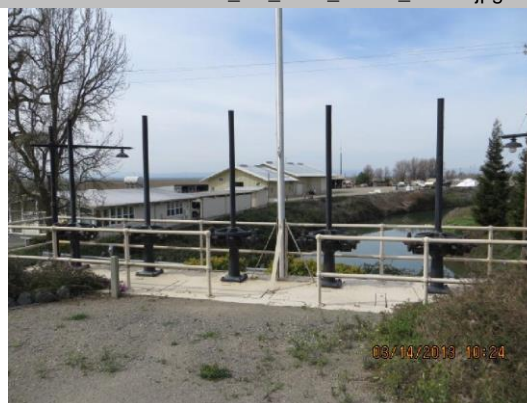
Photo 2 of 3 : UCIP_SP_2017_10276_17512.jpg

LM Start	25.57	Rating **	A/W	Issue No.	1584 (cont)
LM End	25.57	Issue Type +	Ma	Location *	WS
Category	Supplemental			GPS Latitude/Longitude	
				Start	End
Item	DWR UCIP LMA Responsibility			39.012401 °	39.012401 °
				-121.827925 °	-121.827925 °
DWR ID					
Comment Code					
Inspector Comment					
FS_ID:10276					
DS_ID:20374					
EP_NO: 9354					
Repair Type: No Action Needed					
Crossing Status: Found					
UCIP Comments:					
FIELD_STRUCT_DESC: 6 of 6: 5'x5' reinforced concrete culverts					
through levee 40.0 feet below crown (Permit No. 9354, 1960). Control					
gates on the landward and waterward shoulder. Pumps on the					
waterward berm.					
FS Date: 3/14/2013

Slide gates on LS shoulder.

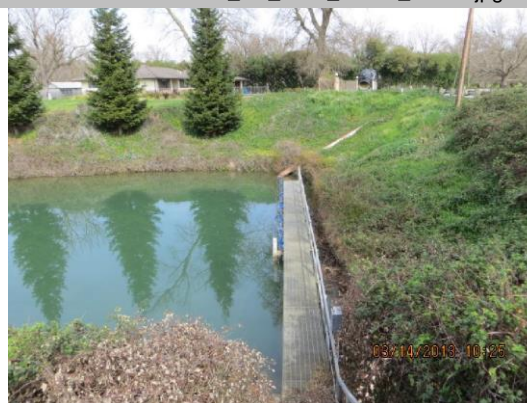
Photo 3 of 3 : UCIP_SP_2017_10276_17511.jpg

Walkway and gates at canal on LS toe.

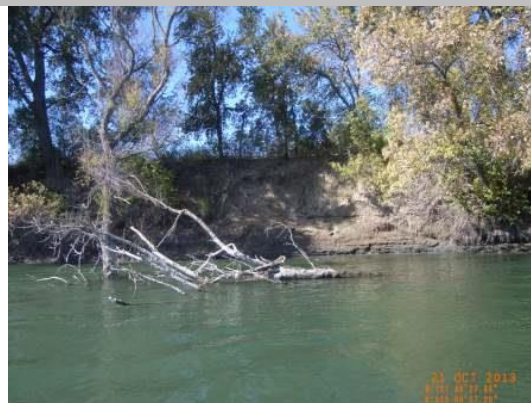
Photo 1 of 1 : SP_2017_NA0016_435_12_20170320_00012.jpg

LM Start	25.75	Rating **	A/W	Issue No.	12
LM End	25.91	Issue Type +	Ma	Location *	WS
Category	Supplemental			GPS Latitude/Longitude	
				Start	End
Item	2015 USACE Erosion Survey, DRAFT			39.014499 °	39.016401 °
				-121.825880 °	-121.824230 °
DWR ID	DWR_NA0016_01_s_2016_12				
Comment Code					
Inspector Comment					
2008 - Whole bank is eroding, nearly vertical slope with cohesive toe. Bed is very deep along the toe (greater than 30 ft deep at 20 ft from the shore). 2011 - Some new minor erosion. 2015: No observed changes. [2015 Site ID: SAC_118-0_R]

USACE 2013 Photo #1

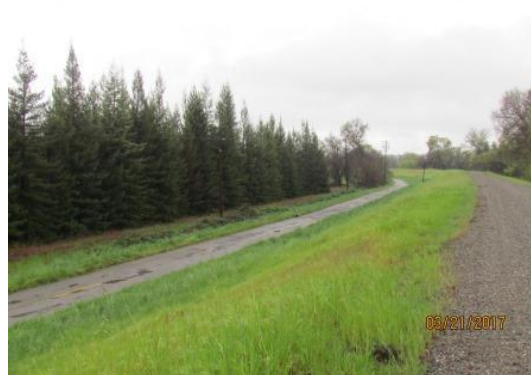
Photo 1 of 1 : SP_2017_NA0016_435_138_20170414_00313.jpg

LM Start	25.97	Rating **	M	Issue No.	138
LM End	27.49	Issue Type +	Ma	Location *	LS
Category	Earthen Levee			GPS Latitude/Longitude	
				Start	End
Item	Vegetation			39.017307 °	39.034252 °
				-121.824029 °	-121.833336 °
DWR ID	DWR_NA0016_01_s_2017_138				
Comment Code					
V1 : Control annual grass and weeds on the levee slopes and easements.					
Inspector Comment

Tall vegetation on the landward levee slope. Spring 2017.

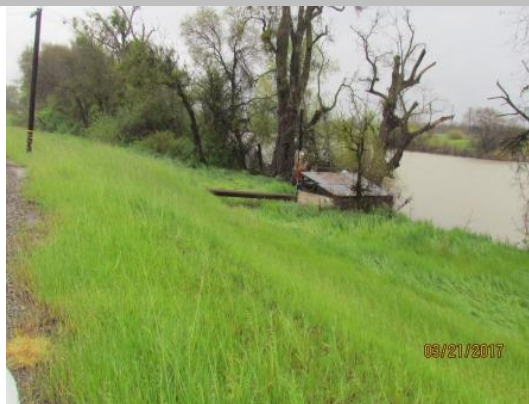
Photo 1 of 1 : SP_2017_NA0016_435_141_20170414_00315.jpg

LM Start	26.56	Rating **	M	Issue No.	141
LM End	26.89	Issue Type +	Ma	Location *	WS
Category	Earthen Levee			GPS Latitude/Longitude	
				Start	End
Item	Vegetation			39.025368 °	39.029879 °
				-121.823414 °	-121.824327 °
DWR ID	DWR_NA0016_01_s_2017_141				
Comment Code					
V1 : Control annual grass and weeds on the levee slopes and easements.					
Inspector Comment

Tall vegetation on waterside slope. Spring 2017.

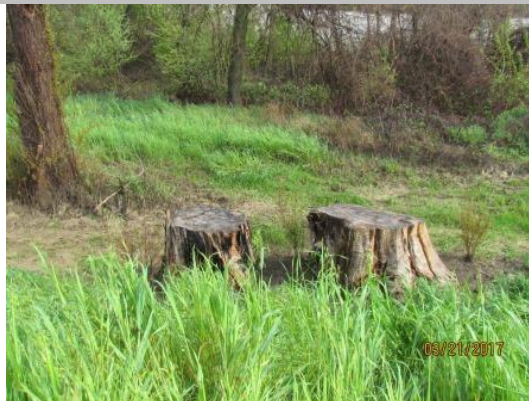
Photo 1 of 1 : SP_2017_NA0016_435_143_20170414_00317.jpg

LM Start	27.22	Rating **	N	Issue No.	143
LM End	27.22	Issue Type +	Ma	Location *	WS
Category	Earthen Levee			GPS Latitude/Longitude	
				Start	End
Item	Trim / Thin Trees			39.031406 °	39.031406 °
				-121.830245 °	-121.830245 °
DWR ID	DWR_NA0016_01_s_2017_143				
Comment Code					
T5 : Tree stumps.					
Inspector Comment					
Two stumps on waterside levee toe.

Two stumps at waterside toe. Spring 2017.

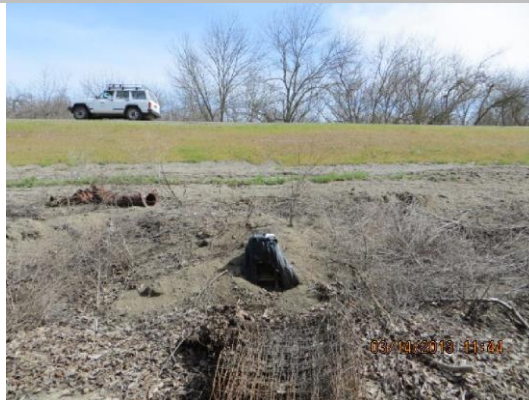
Photo 1 of 3 : UCIP_SP_2017_10291_17548.jpg

LM Start	27.54	Rating **	M	Issue No.	1588
LM End	27.54	Issue Type +	Ma	Location *	WS
Category	Supplemental			GPS Latitude/Longitude	
				Start	End
Item	DWR UCIP LMA Responsibility			39.034870 °	39.034870 °
				-121.833501 °	-121.833501 °
DWR ID					
Comment Code					
Inspector Comment					
FS_ID:10291 DS_ID:20257 EP_NO: 9355 Repair Type: Non-Urgent Crossing Status: Found UCIP Comments: Pipe needs to be properly abandoned. FIELD_STRUCT_DESC: *ABANDONED* 24-inch steel pipe through levee 14.0 feet below crown. Slide gate on the waterward end, gate valve on the landward end (ABO No. 9355, 1960). Originally included in the 1960 O&M manual. FS Date: 3/14/2013

Gate valve buried on LS toe.

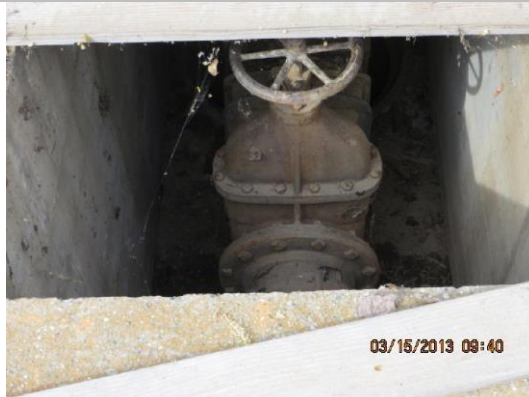
Photo 1 of 3 : UCIP_SP_2017_10306_17566.jpg

LM Start	28.64	Rating **	A/W	Issue No.	1590
LM End	28.64	Issue Type +	Ma	Location *	WS
Category	Supplemental			GPS Latitude/Longitude	
				Start	End
Item	DWR UCIP LMA Responsibility			39.048281 °	39.048281 °
				-121.841084 °	-121.841084 °
DWR ID					
Comment Code					
Inspector Comment					
FS_ID:10306 DS_ID:20341 EP_NO: 9358 Repair Type: No Action Needed Crossing Status: Found UCIP Comments: FIELD_STRUCT_DESC: 1 of 6: 16-inch steel storm drain pipe through levee 8.5 feet below crown. Siphon breaker in 24-inch corrugated metal riser unit on the Waterward slope. Pump in pump house on the landward side. Overhead power line crosses the levee. Pole on the landward shoulder (Permit No. 9358, 1960). Originally included in the 1960 O&M manual. FS Date: 3/15/2013

Gate valve under pumphouse on LS toe.

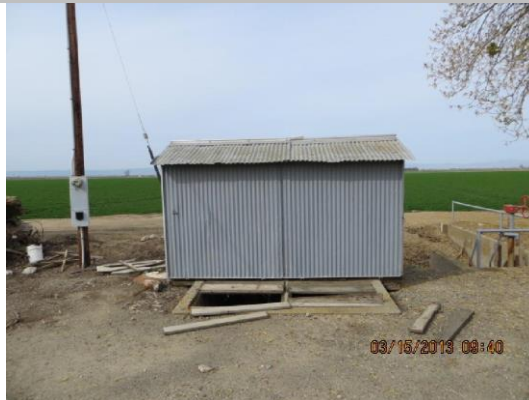
Photo 2 of 3 : UCIP_SP_2017_10306_17565.jpg

Pumphouse and sump on LS toe.

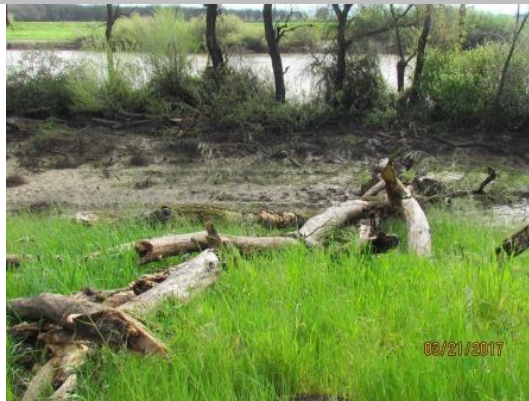
Photo 1 of 1 : SP_2017_NA0016_435_148_20170414_00319.jpg

LM Start	29.23	Rating **	M	Issue No.	148
LM End	29.23	Issue Type +	Ma	Location *	WS
Category	Earthen Levee			GPS Latitude/Longitude	
				Start	End
Item	Encroachments			39.056690 °	39.056690 °
				-121.840852 °	-121.840852 °
DWR ID	DWR_NA0016_01_s_2017_148				
Comment Code					
TR : Tree or limb					
Inspector Comment

Downed tree on waterside slope. Spring 2017.

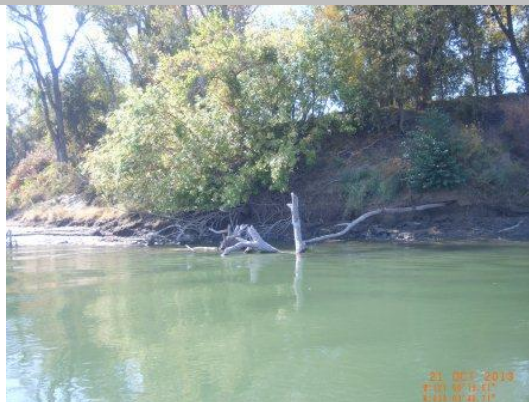
Photo 1 of 1 : SP_2017_NA0016_435_2_20170320_00002.jpg

LM Start	29.69	Rating **	A/W	Issue No.	2
LM End	29.73	Issue Type +	Ma	Location *	WS
Category	Supplemental			GPS Latitude/Longitude	
				Start	End
Item	2015 USACE Erosion Survey, DRAFT			39.063209 °	39.063997 °
				-121.838927 °	-121.839335 °
DWR ID	DWR_NA0016_01_s_2016_2				
Comment Code					
Inspector Comment					
1997 - Mass failure of the lower cohesive bank and toe. 2000 - Still eroding, steeply dipping foresets in the toe are falling off. 2010 - Some new erosion and some new deposition. Eddy current off the upstream rock. 2011 - Still plenty of berm left. 2015: No observed changes. [2015 Site ID: SAC_122-0_R]

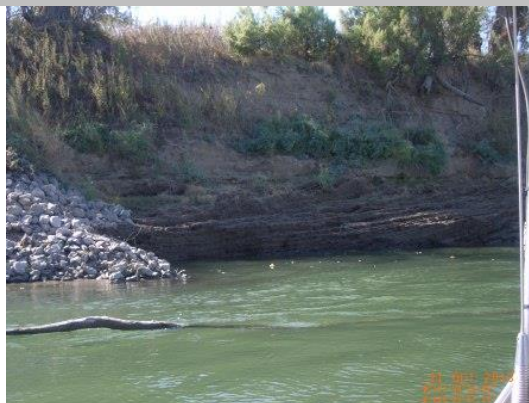
Photo 1 of 1 : SP_2017_NA0016_435_13_20170320_00013.jpg

LM Start	29.96	Rating **	M	Issue No.	13
LM End	30.00	Issue Type +	Ma	Location *	WS
Category	Supplemental			GPS Latitude/Longitude	
				Start	End
Item	2015 USACE Erosion Survey, DRAFT			39.065886 °	39.066287 °
				-121.842950 °	-121.843602 °
DWR ID	DWR_NA0016_01_s_2016_13				
Comment Code					
Inspector Comment					
2002 - Upstream end has recent slope failure and exposure of tree roots. 2003 - Some new minor slope erosion with new snags on the bank. 2004 - Appears a little worse. 2005 - Scallop in bank at the upstream end looks worse. 2009 - Minimal new erosion, Berm width is still large, but one large event or one fallen tree and it could go fast. 2010 - New erosion, bank is nearly all vertical from slumping. Site looks bad. 2011 - Site continues to look bad. 2012 - Minor new erosion. 2015: Undermining of toe rock. [2015 Site ID: SAC_122-3_R]

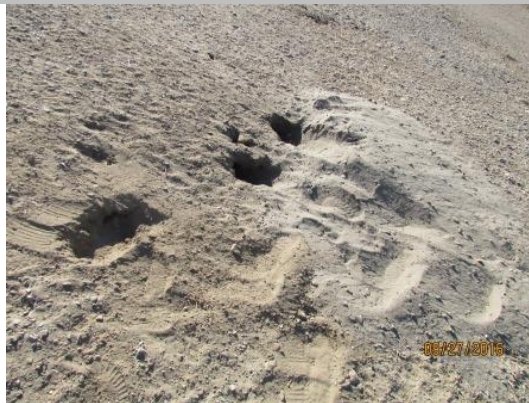
Photo 2 of 2 : SP_2017_NA0016_435_79_20170320_00034.jpg

Burrows on landside slope. Fall 2016 inspection.

LM Start	30.28	Rating **	U	Issue No.	79 (cont)	
LM End	30.28	Issue Type +	Ma	Location *	LS	
Category	Earthen Levee			GPS Latitude/Longitude		
				Start		End
Item	Animal Control			39.068949 °		39.068949 °
				-121.847551 °		-121.847551 °
DWR ID	DWR_NA0016_01_f_2016_79					
Comment Code						
A1 : Exterminate rodents and backfill and compact or grout burrows.						
Inspector Comment

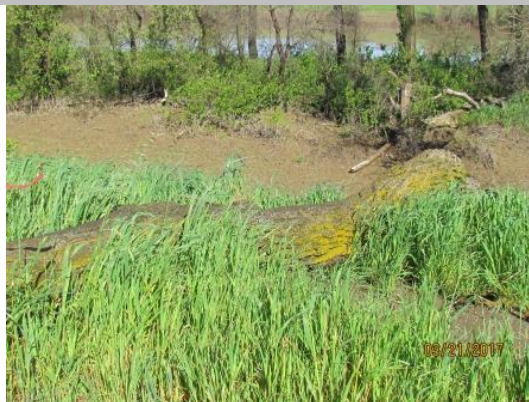
Photo 1 of 1 : SP_2017_NA0016_435_151_20170414_000321.jpg

LM Start	30.96	Rating **	M	Issue No.	151
LM End	30.96	Issue Type +	Ma	Location *	WS
Category	Earthen Levee			GPS Latitude/Longitude	
				Start	End
Item	Encroachments			39.067836 °	39.067836 °
				-121.858386 °	-121.858386 °
DWR ID	DWR_NA0016_01_s_2017_151				
Comment Code					
TR : Tree or limb					
Inspector Comment					
Large tree downed on waterside slope.

Downed tree on waterside levee slope, looking towards river. Spring 2017.

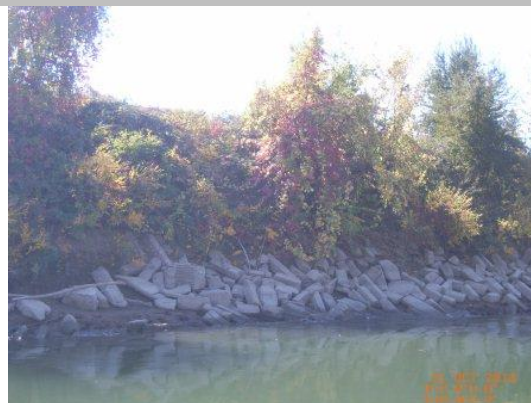
Photo 1 of 1 : SP_2017_NA0016_435_17_20170320_00016.jpg

LM Start	31.43	Rating **	M	Issue No.	17
LM End	31.45	Issue Type +	Ma	Location *	WS
Category	Supplemental			GPS Latitude/Longitude	
				Start	End
Item	2015 USACE Erosion Survey, DRAFT			39.067004 °	39.066901 °
				-121.866913 °	-121.867322 °
DWR ID	DWR_NA0016_01_s_2016_17				
Comment Code					
Inspector Comment					
1997 - Erosion into the levee section; old concrete rubble loss at toe; transition between the rock upstream and the cobble downstream. 2000 - Cohesive bench with concrete slabs on top; 25 ft deep scour hole on the downstream end. 2015: No observed changes. [2015 Site ID: SAC 123-7 R]

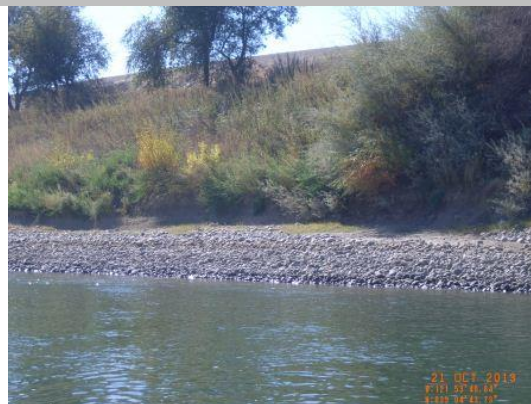
Photo 1 of 1 : SP_2017_NA0016_435_5_20170320_00005.jpg

LM Start	33.29	Rating **	A/W	Issue No.	5
LM End	33.37	Issue Type +	Ma	Location *	WS
Category	Supplemental			GPS Latitude/Longitude	
				Start	End
Item	2015 USACE Erosion Survey, DRAFT			39.078340 °	39.079351 °
				-121.894656 °	-121.895317 °
DWR ID	DWR_NA0016_01_s _ 2016_5				
Comment Code					
Inspector Comment					
2008 - Slow erosion of the hard toe. 2010 - Cobble rubble is failing, erosion is into the toe of the levee, with vertical slumping. 2012 - Site appears to be relatively stable. 2013 - New animal holes. 2015: No observed changes. [2015 Site ID: SAC_125-6_R]

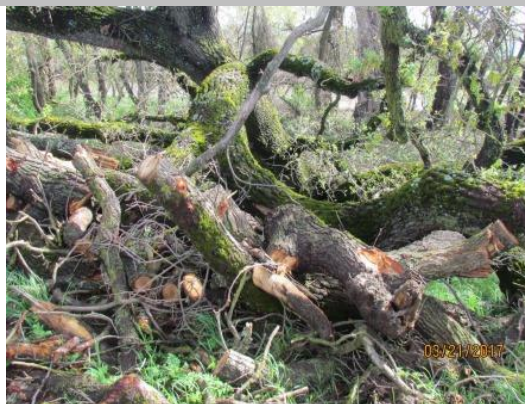
Photo 1 of 1 : SP_2017_NA0016_435_165_20170417_00325.jpg

LM Start	34.49	Rating **	M	Issue No.	165
LM End	34.49	Issue Type +	Ma	Location *	WS
Category	Earthen Levee			GPS Latitude/Longitude	
				Start	End
Item	Encroachments			39.094072 °	39.094072 °
				-121.894877 °	-121.894877 °
DWR ID	DWR_NA0016_01_s_2017_165				
Comment Code					
TR : Tree or limb					
Inspector Comment

Fallen tree on waterside slope, looking towards river. Spring 2017.

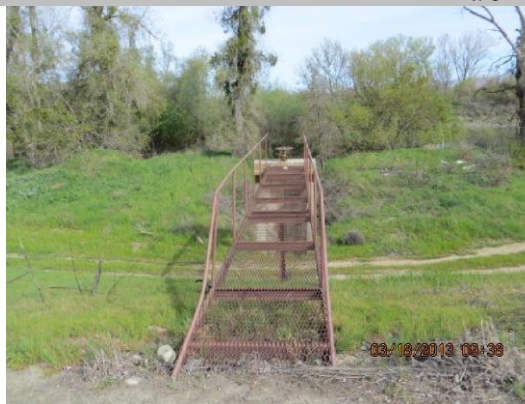
Photo 1 of 3 : UCIP_SP_2017_10406_17666.jpg

LM Start	34.72	Rating **	A/W	Issue No.	1597
LM End	34.72	Issue Type +	Ma	Location *	WS
Category	Supplemental			GPS Latitude/Longitude	
				Start	End
Item	DWR UCIP LMA Responsibility			39.095621 °	39.095621 °
				-121.897340 °	-121.897340 °
DWR ID					
Comment Code					
Inspector Comment					
FS_ID:10406 DS_ID:20270 EP_NO: 494 Repair Type: No Action Needed Crossing Status: Found UCIP Comments: FIELD_STRUCT_DESC: 48-inch corrugated metal drainage pipe through levee 23.0 feet below crown. Slide gate on concrete headwall on the waterward end. Walkway provided to control gate. (Permit No. 494, 1930). Included in the 1960 O&M manual and ABO 9363. FS Date: 3/18/2013

Walkway to slidegate on WS berm.

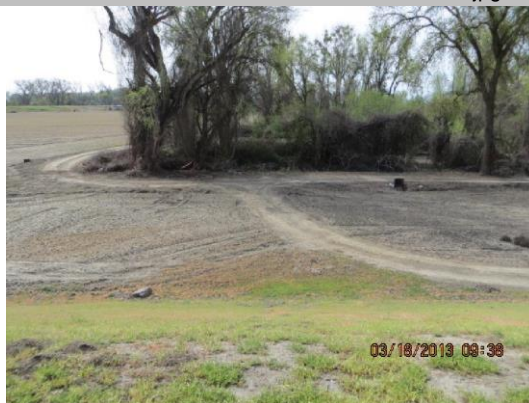
Photo 2 of 3 : UCIP_SP_2017_10406_17665.jpg

Inlet in vegetated area off LS toe.

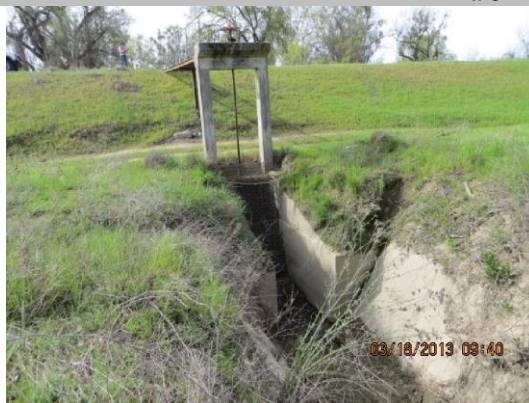
Photo 3 of 3 : UCIP_SP_2017_10406_17664.jpg

Concrete outlet and slide gate at WS toe.

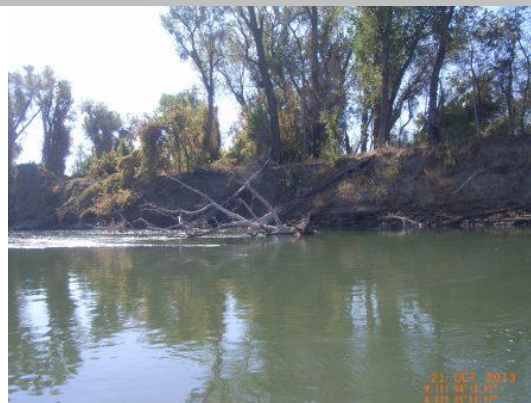
Photo 1 of 1 : SP_2017_NA0016_435_1_20170320_00001.jpg

LM Start	35.23	Rating **	A/W	Issue No.	1
LM End	35.33	Issue Type +	Ma	Location *	WS
Category	Supplemental			GPS Latitude/Longitude	
				Start	End
Item	2015 USACE Erosion Survey, DRAFT			39.099482 °	39.100836 °
				-121.903430 °	-121.904320 °
DWR ID	DWR_NA0016_01_s_2016_1				
Comment Code					
Inspector Comment					
1997 - Major scour off the downstream end of existing rock, creating a scour pocket where the levee starts diverging from the bankline. 2000 - Some minor erosion, 20 ft deep hole at downstream end. 2004 - Small amount of new erosion. 2010 - Bad transition off downstream end of rock revetment, some new erosion. 2012 - Site extended downstream, minor new erosion. 2013- Minor new erosion. 2015: No observed changes. [2015 Site ID: SAC_127-9_R]

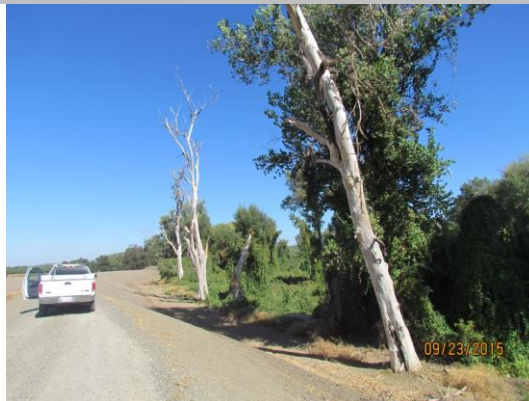
Photo 1 of 1 : SP_2017_NA0016_435_139_20170320_00071.jpg

LM Start	35.69	Rating **	A/W	Issue No.	139
LM End	35.69	Issue Type +	Ma	Location *	WS
Category	Earthen Levee			GPS Latitude/Longitude	
				Start	End
Item	Vegetation			39.105381 °	39.105381 °
				-121.907770 °	-121.907770 °
DWR ID	DWR_NA0016_01_f_2015_139				
Comment Code					
V7 : Trees / Woody Vegetation					
Inspector Comment

View of the dying tree on the waterward side of the levee looking upstream. Fall 2015.

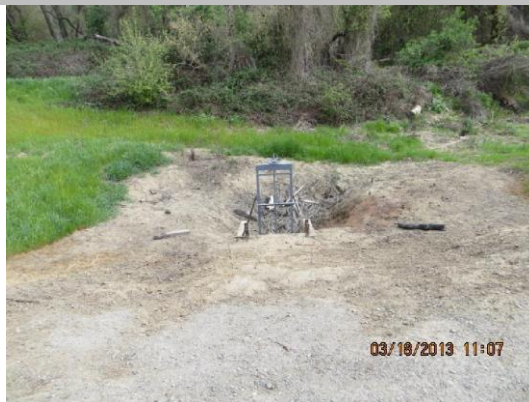
Photo 1 of 3 : UCIP_SP_2017_10426_17705.jpg

LM Start	36.15	Rating **	M	Issue No.	1600
LM End	36.15	Issue Type +	Ma	Location *	WS
Category	Supplemental			GPS Latitude/Longitude	
				Start	End
Item	DWR UCIP LMA Responsibility			39.111233 °	39.111233 °
				-121.911450 °	-121.911450 °
DWR ID					
Comment Code					
Inspector Comment					
FS_ID:10426 DS_ID:20345 EP_NO: 9374 Repair Type: Non-Urgent Crossing Status: Found UCIP Comments: Verify if pipe is abandoned with landowner and remove or abandon properly if necessary. FIELD_STRUCT_DESC: *ABANDONED* 3 of 3: 24-inch concrete encased steel drain pipe through levee 17.0 feet below crown. Slide gate on concrete headwalls in waterward end, walkway to control gate and gate valve on landward end (ABO No. 9374, 1960). Originally included in the 1960 O&M manual. FS Date: 3/18/2013

Slide gate on WS toe.

FS_ID:10426
DS_ID:20345
EP_NO: 9374
Repair Type: Non-Urgent
Crossing Status: Found
UCIP Comments: Verify if pipe is abandoned with landowner and remove or abandon properly if necessary.
FIELD_STRUCT_DESC: *ABANDONED* 3 of 3: 24-inch concrete encased steel drain pipe through levee 17.0 feet below crown. Slide gate on concrete headwalls in waterward end, walkway to control gate and gate valve on landward end (ABO No. 9374, 1960). Originally included in the 1960 O&M manual.
FS Date: 3/18/2013

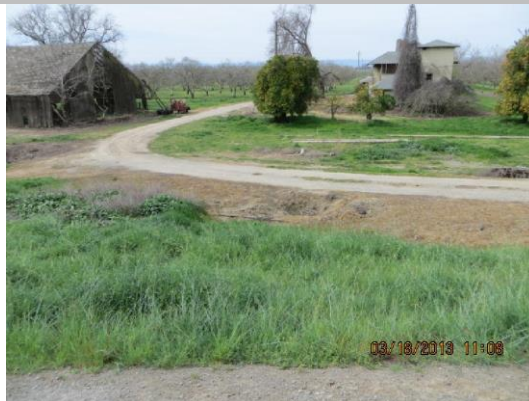
Photo 2 of 3 : UCIP_SP_2017_10426_17704.jpg

Headwall and gate valve on LS toe buried but partially exposed.

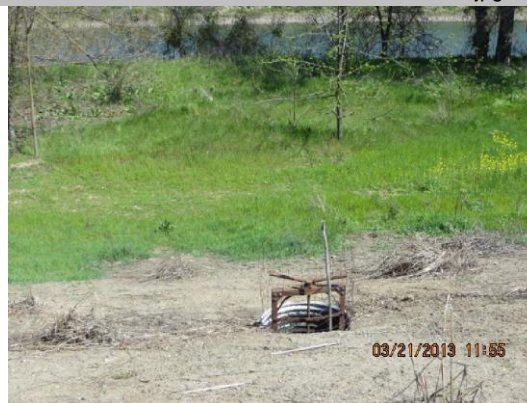
Photo 1 of 3 : UCIP_SP_2017_10535_17877.jpg

FS_ID:10535
DS_ID:20288
EP_NO: N/A
Repair Type: No Action Needed
Crossing Status: Found
UCIP Comments:
FIELD_STRUCT_DESC: 24-inch pipe through levee 19.0 feet below crown. 6-foot diameter CMP standpipe on the landward toe. Pump and 24-inch pipe on the landside. Slide gate in CMP riser on waterward slope. Concrete block wall at waterward toe for discharge line. Originally included in the 1960 O&M manual. Modified under permit No. 8587, 1973.
FS Date: 3/21/2013

Slide gate in CMP riser on WS slope.

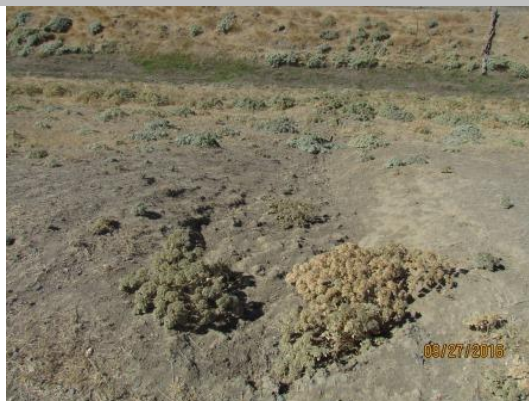
Photo 2 of 2 : SP_2017_NA0016_435_146_20170320_00072.jpg

Slope stability issue due to foot traffic. Fall 2016 inspection.

LM Start	42.73	Rating **	M	Issue No.	146 (cont)	
LM End	42.73	Issue Type +	Ma	Location *	LS	
Category	Earthen Levee			GPS Latitude/Longitude		
				Start		End
Item	Slope Stability			39.169949 °		39.169949 °
				-121.938664 °		-121.938664 °
DWR ID	DWR_NA0016_01_f_2015_146					
Comment Code						
S2 : Repair the levee slope damaged by foot traffic and prevent access where possible.						
Inspector Comment
